Technical Inspection Report  
Bureau of Ordnance Group

OPERATION CROSSROADS.

TESTS 'A' AND 'B'.  
VOLUME III.  
PART I.  
Photographic  
Appendix [u]. 8

Subject: Bureau of Ordnance Material Group Final Report for Tests "A" & "B".

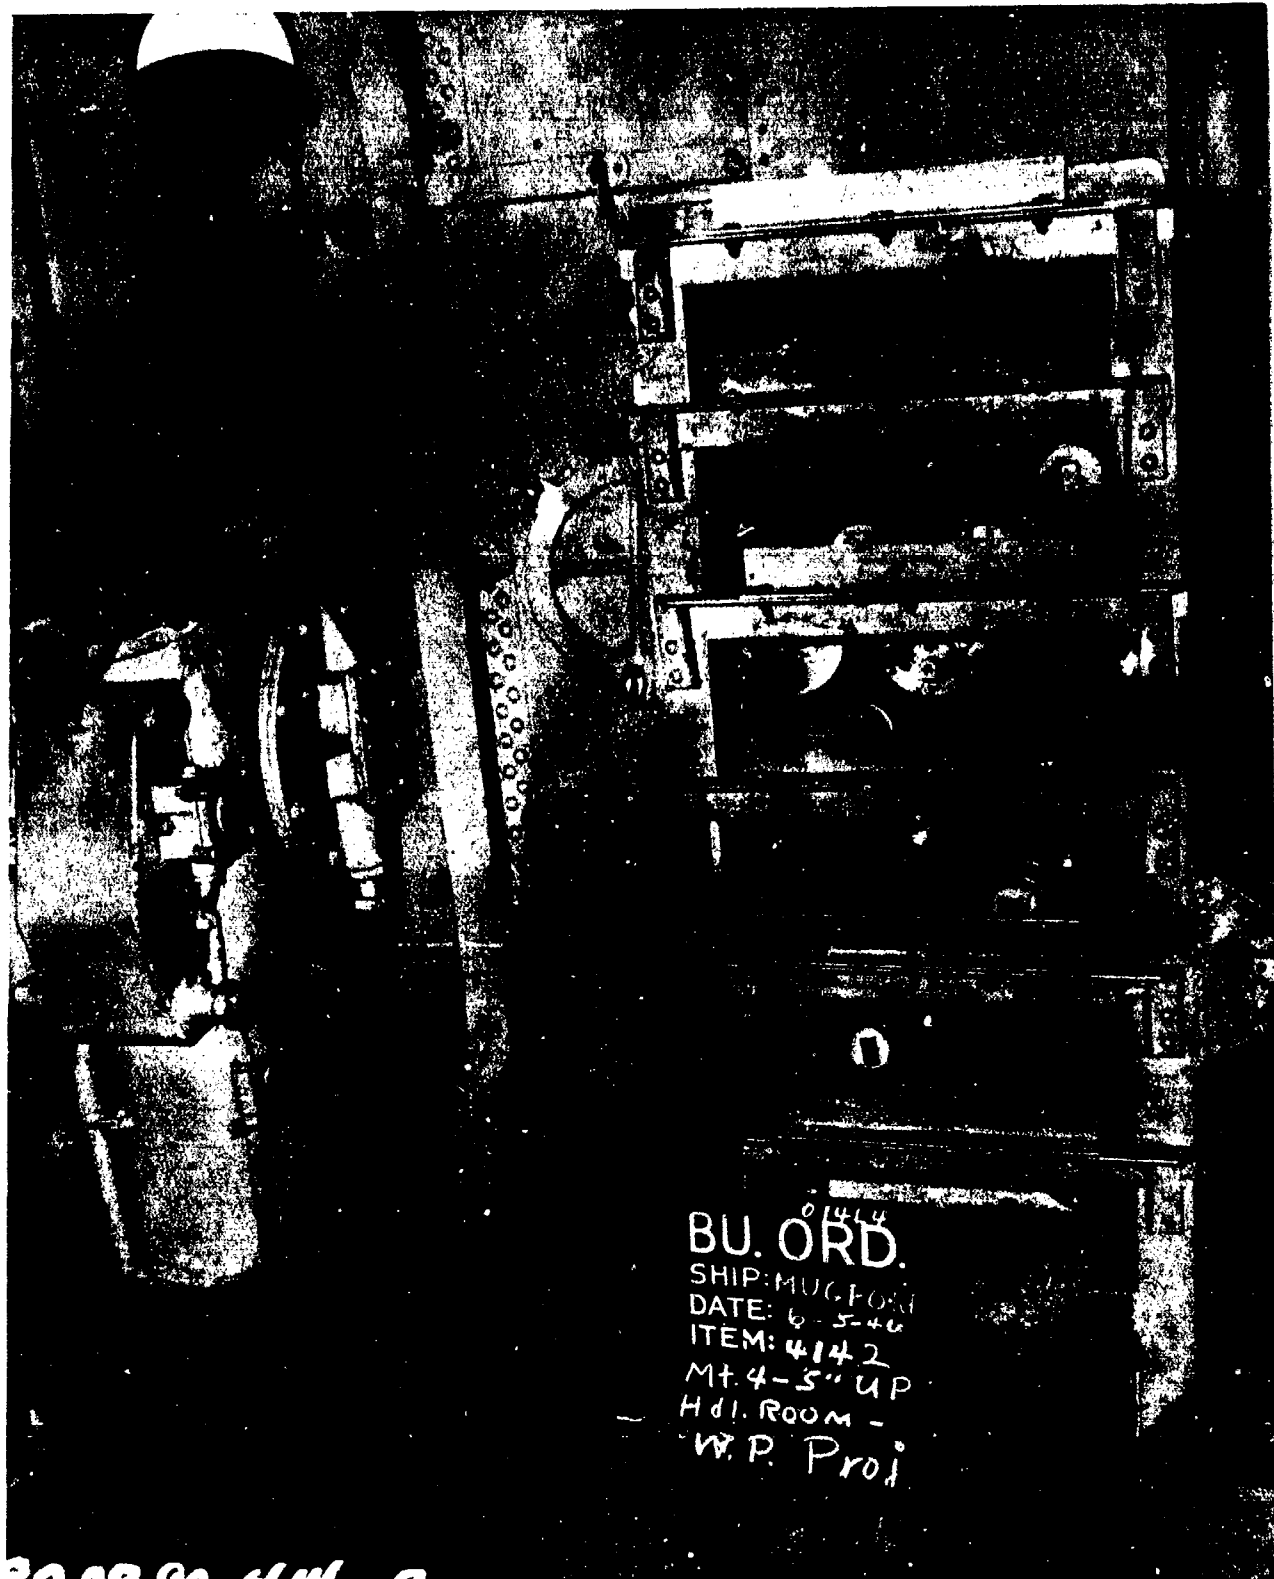
U.S.S. MUGFORD (DD-389) - Before Able  
Shows the 5"/38 White Phosphorous Projectiles in  
position in Mount 4 Upper Handling Room, prior to Test "A".  
Photo. No. BA-CR-92-414-2.

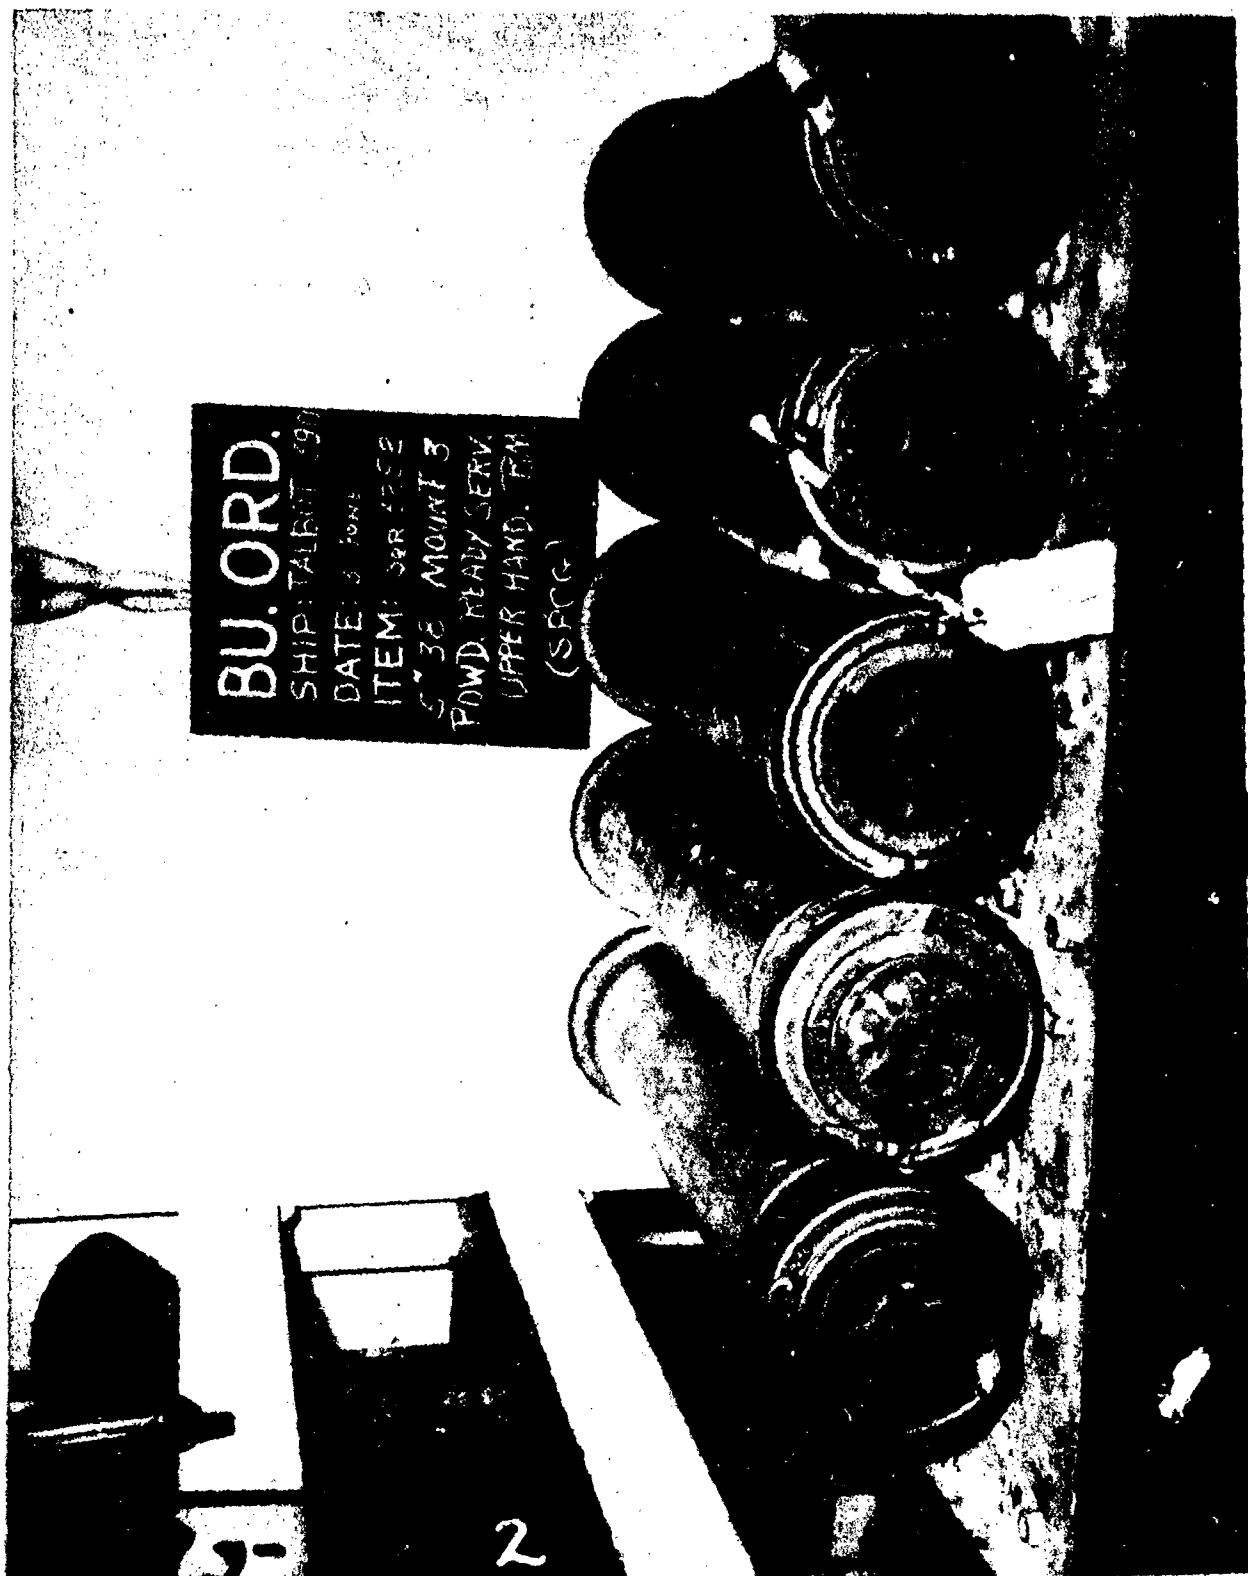
U.S.S. RALPH TALENT (DD-390) - Before Able  
Shows the 5"/38 Special Test Powder (SPCG) in the  
Upper Handling Room of Mount 3 prior to Test "A".  
Photo. No. BA-CR-92-325-2.

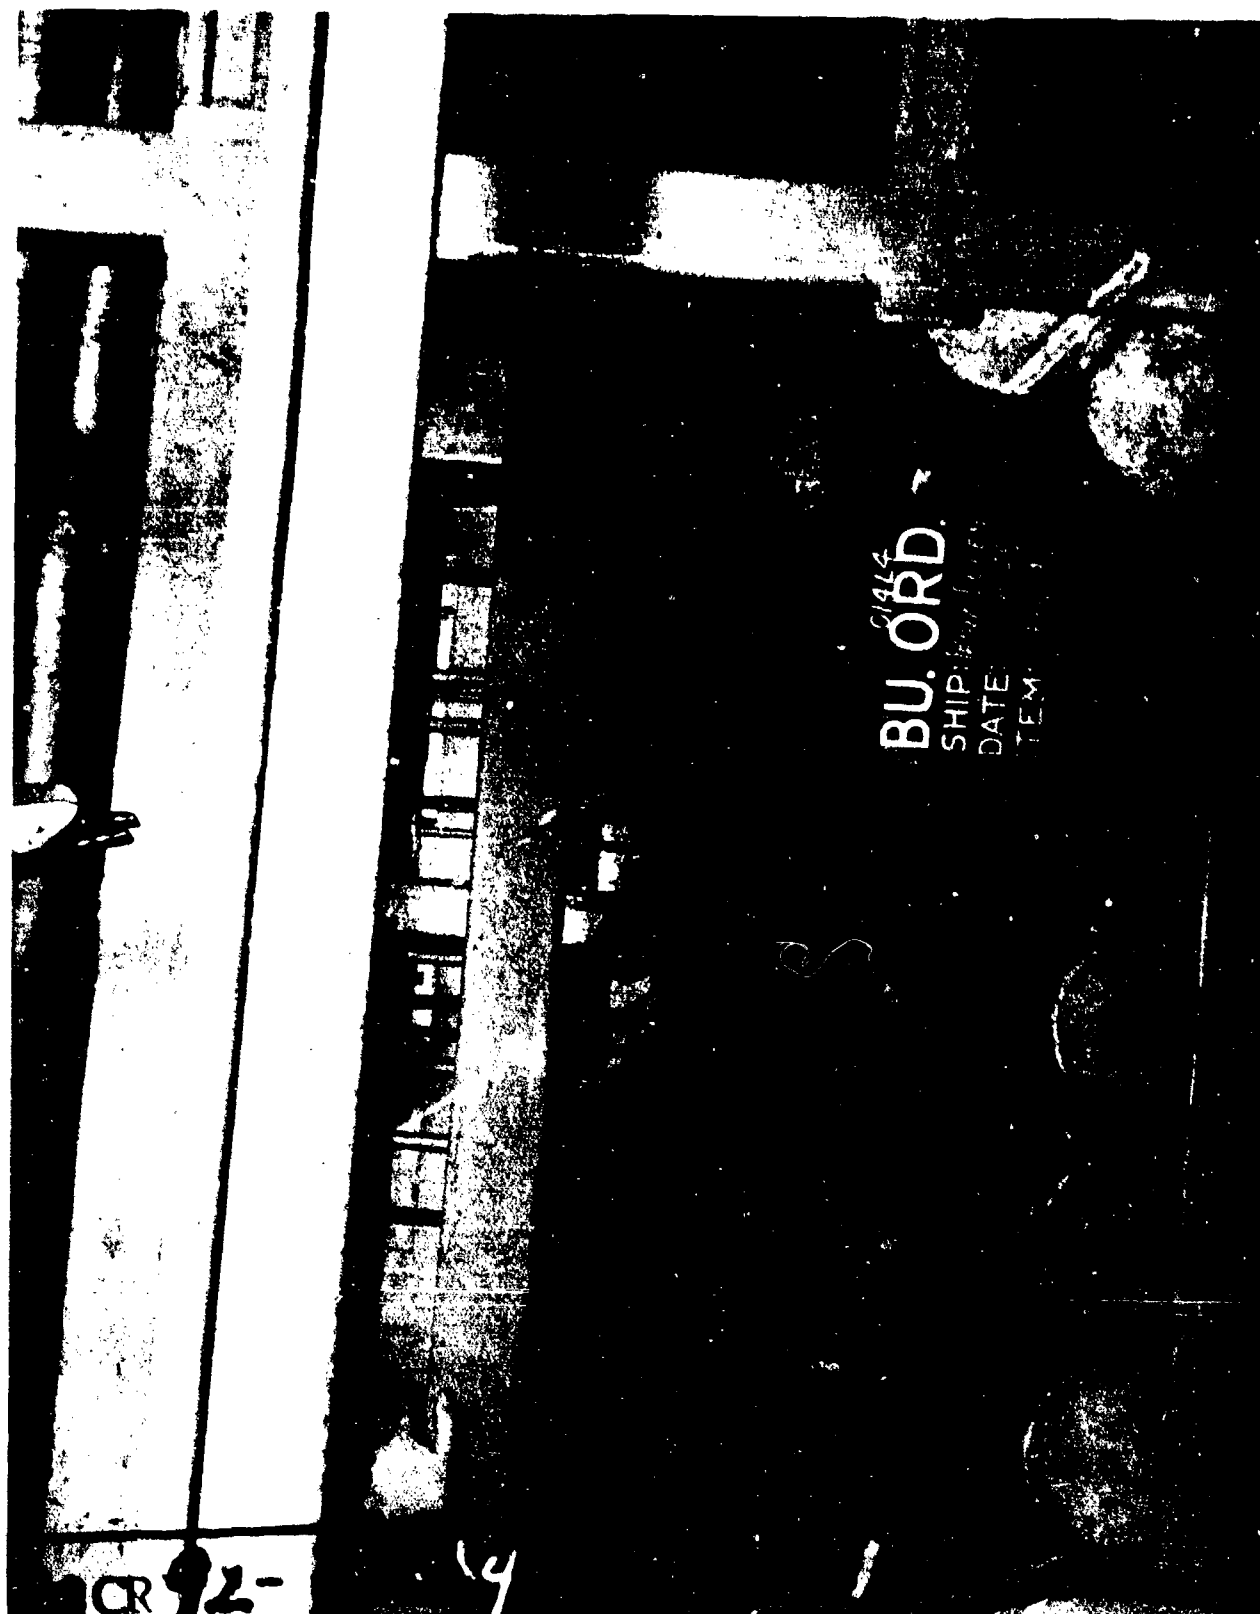
U.S.S. PRINZ EUGEN (CA-Ger) - Before Able  
Shows the 8" powder stowage.  
Photo. No. BA-CR-92-930-1.

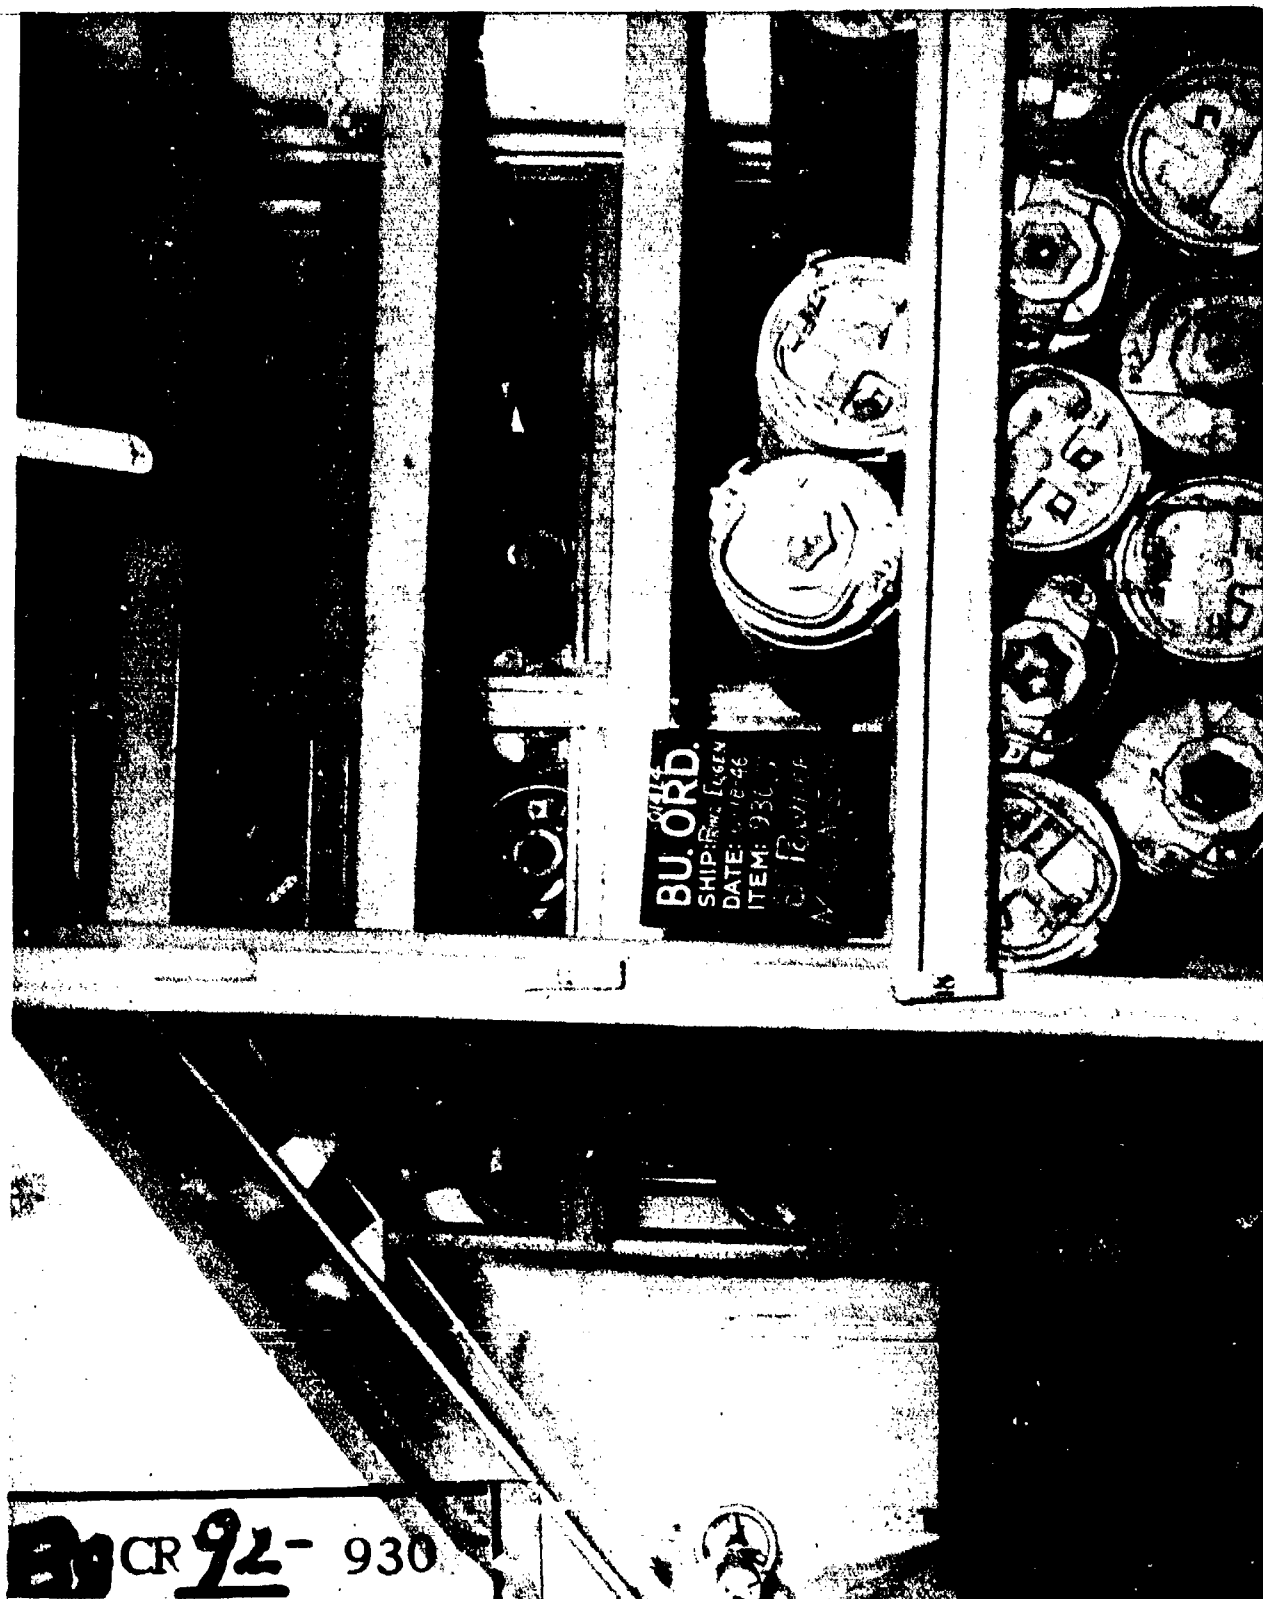
U.S.S. PRINZ EUGEN (CA-66) - Before Able  
Shows the 8" Powder Stowage.  
Photo. No. BA-CR-92-930-5.

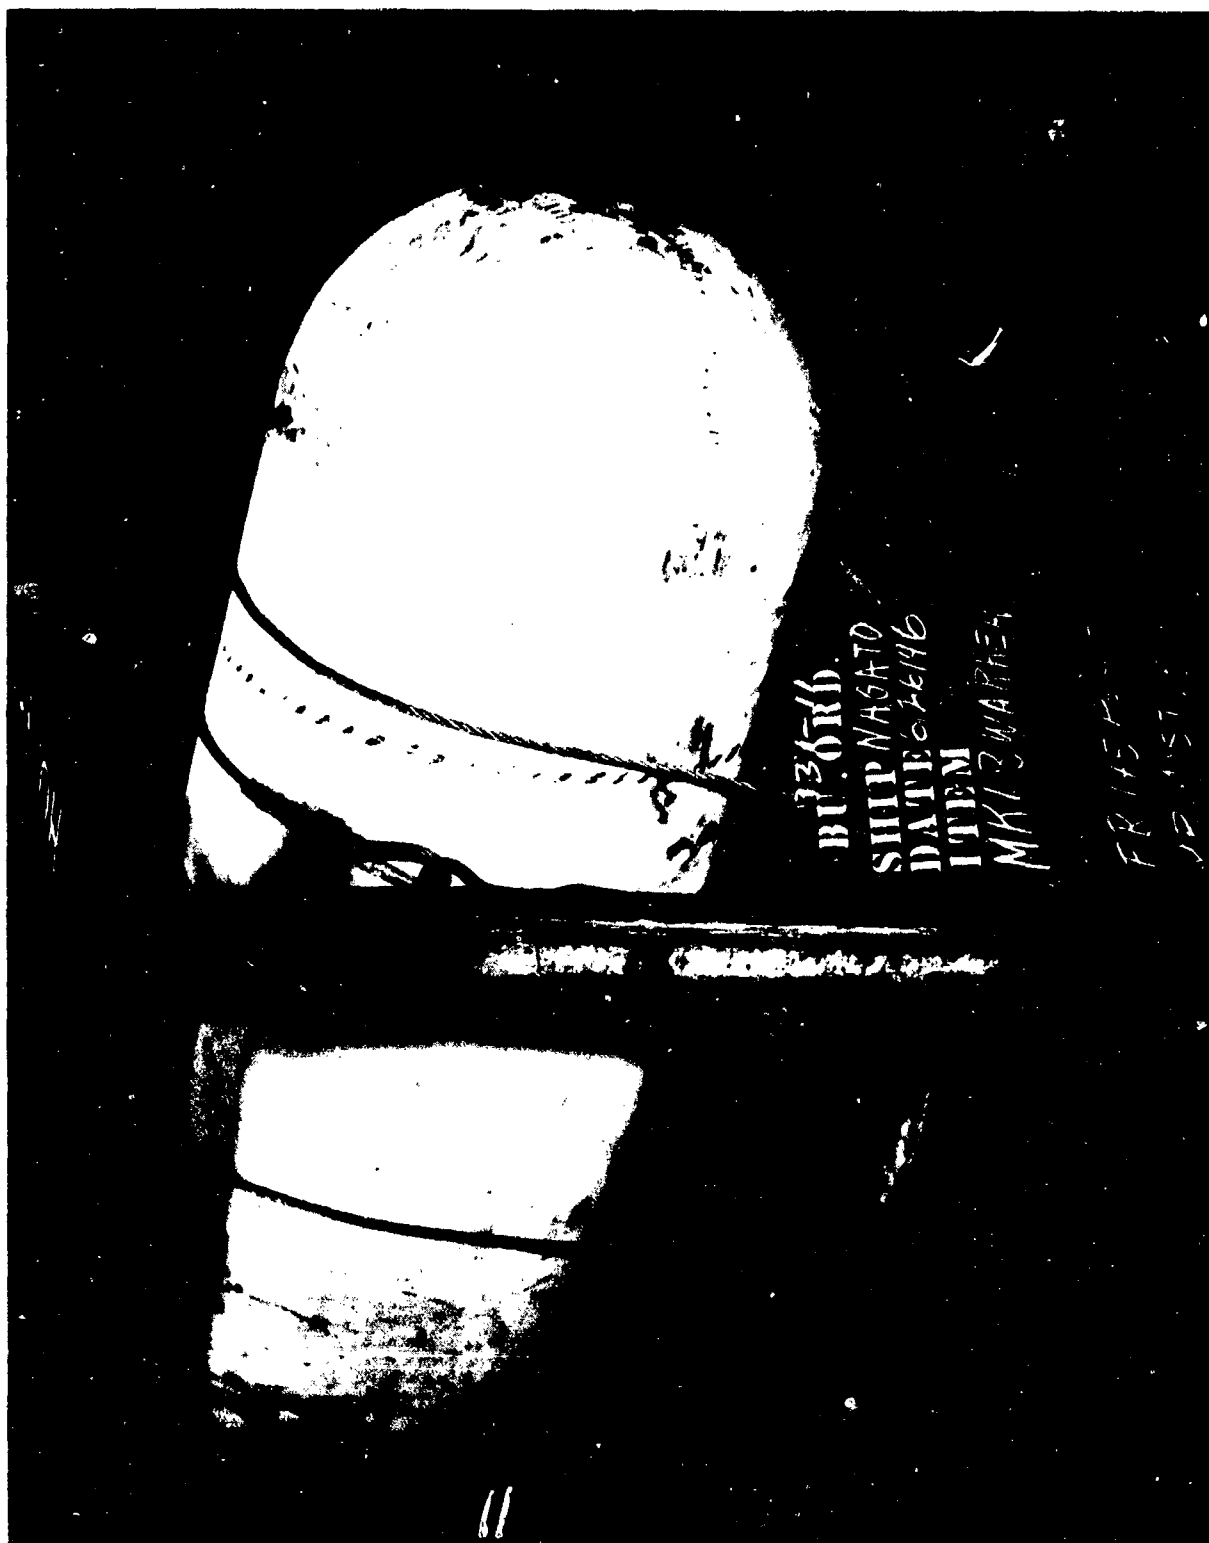
U.S.S. NAGATO (Ex-Jap) - Before Able  
Shows the Warhead, Mk. 13, HBX loaded and  
plugged, (no exploder mechanism) secured in  
position for Test "A". The warhead was located  
on the uppermost deck, frame 145, port side.  
Photo. No. BA-CR-76-131-11.

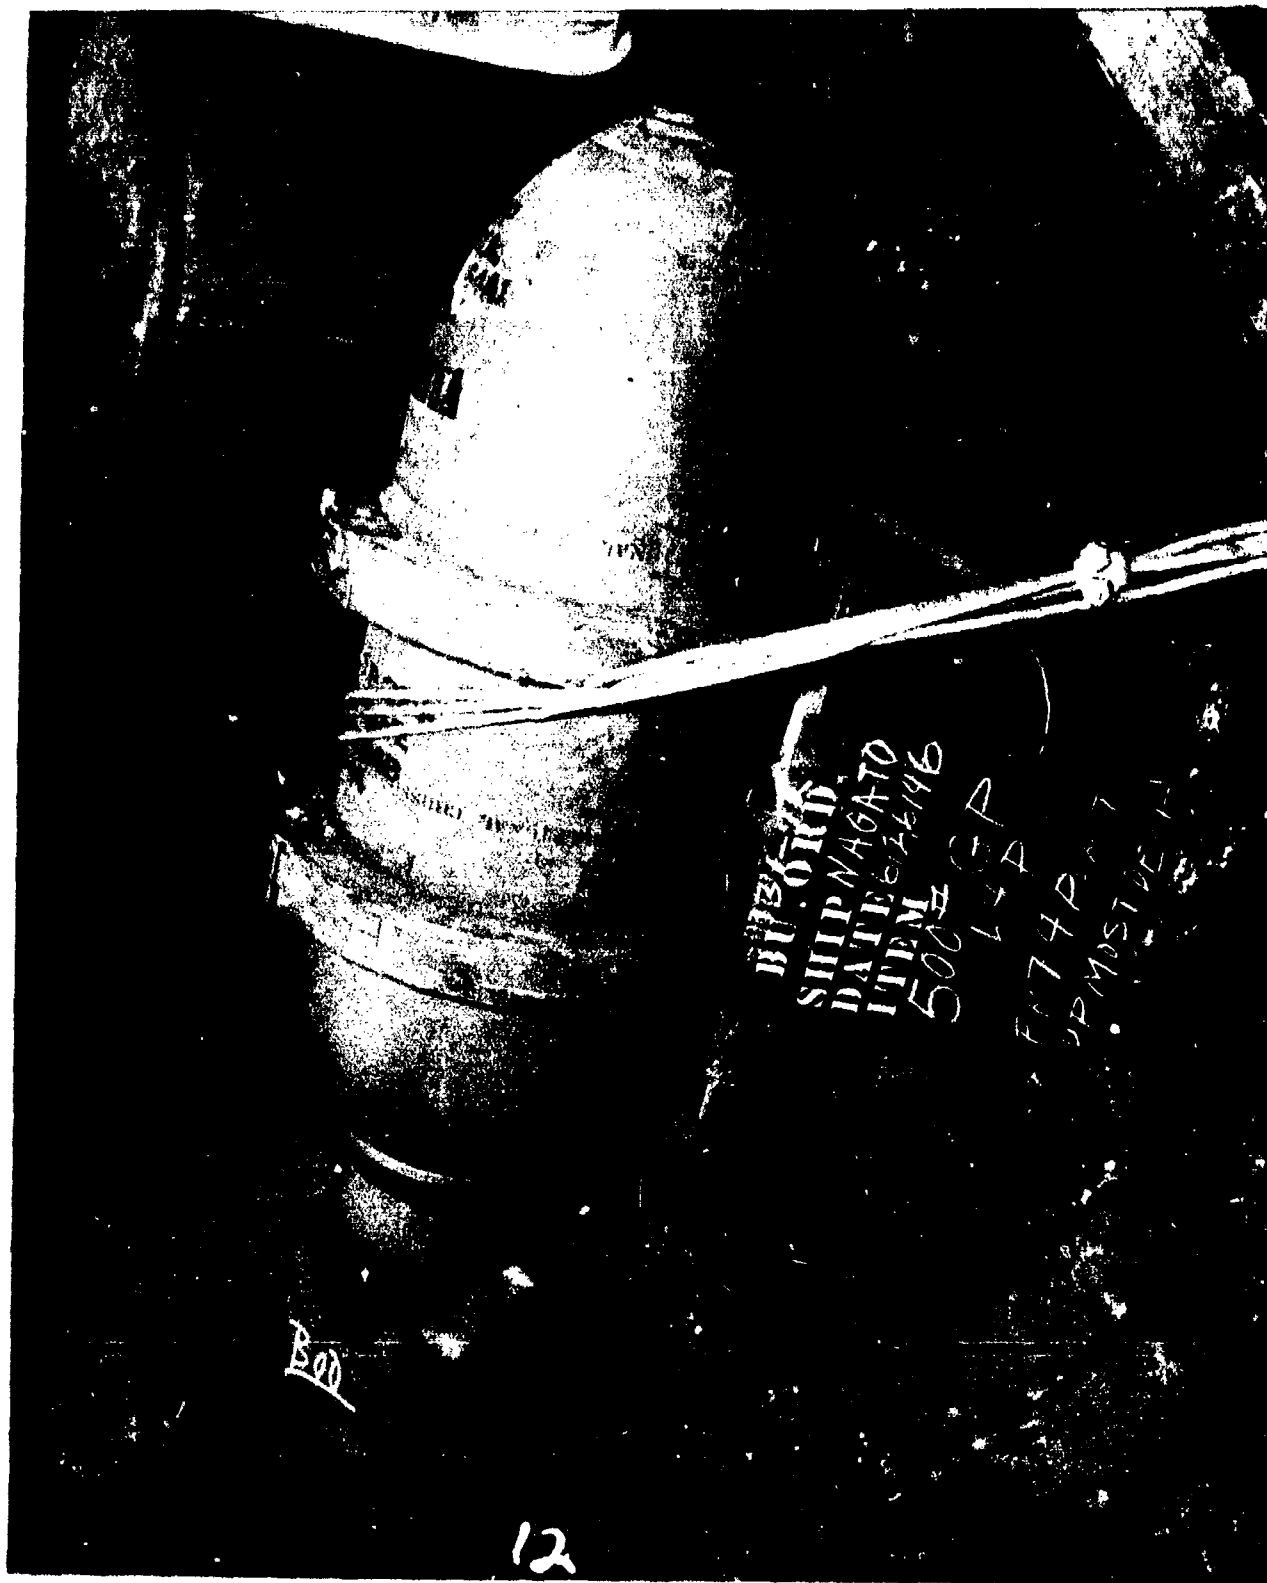
U.S.S. NAGATO (Ex-Jap BB) - Before Able  
Shows the 500 lb., general purpose, aircraft  
bomb, AN-M64A1, TNT loaded and plugged, in position  
for Test "A". The bomb was located on the uppermost  
deck, frame 74, port side.  
Photo. No. BA-CR-76-131-12.

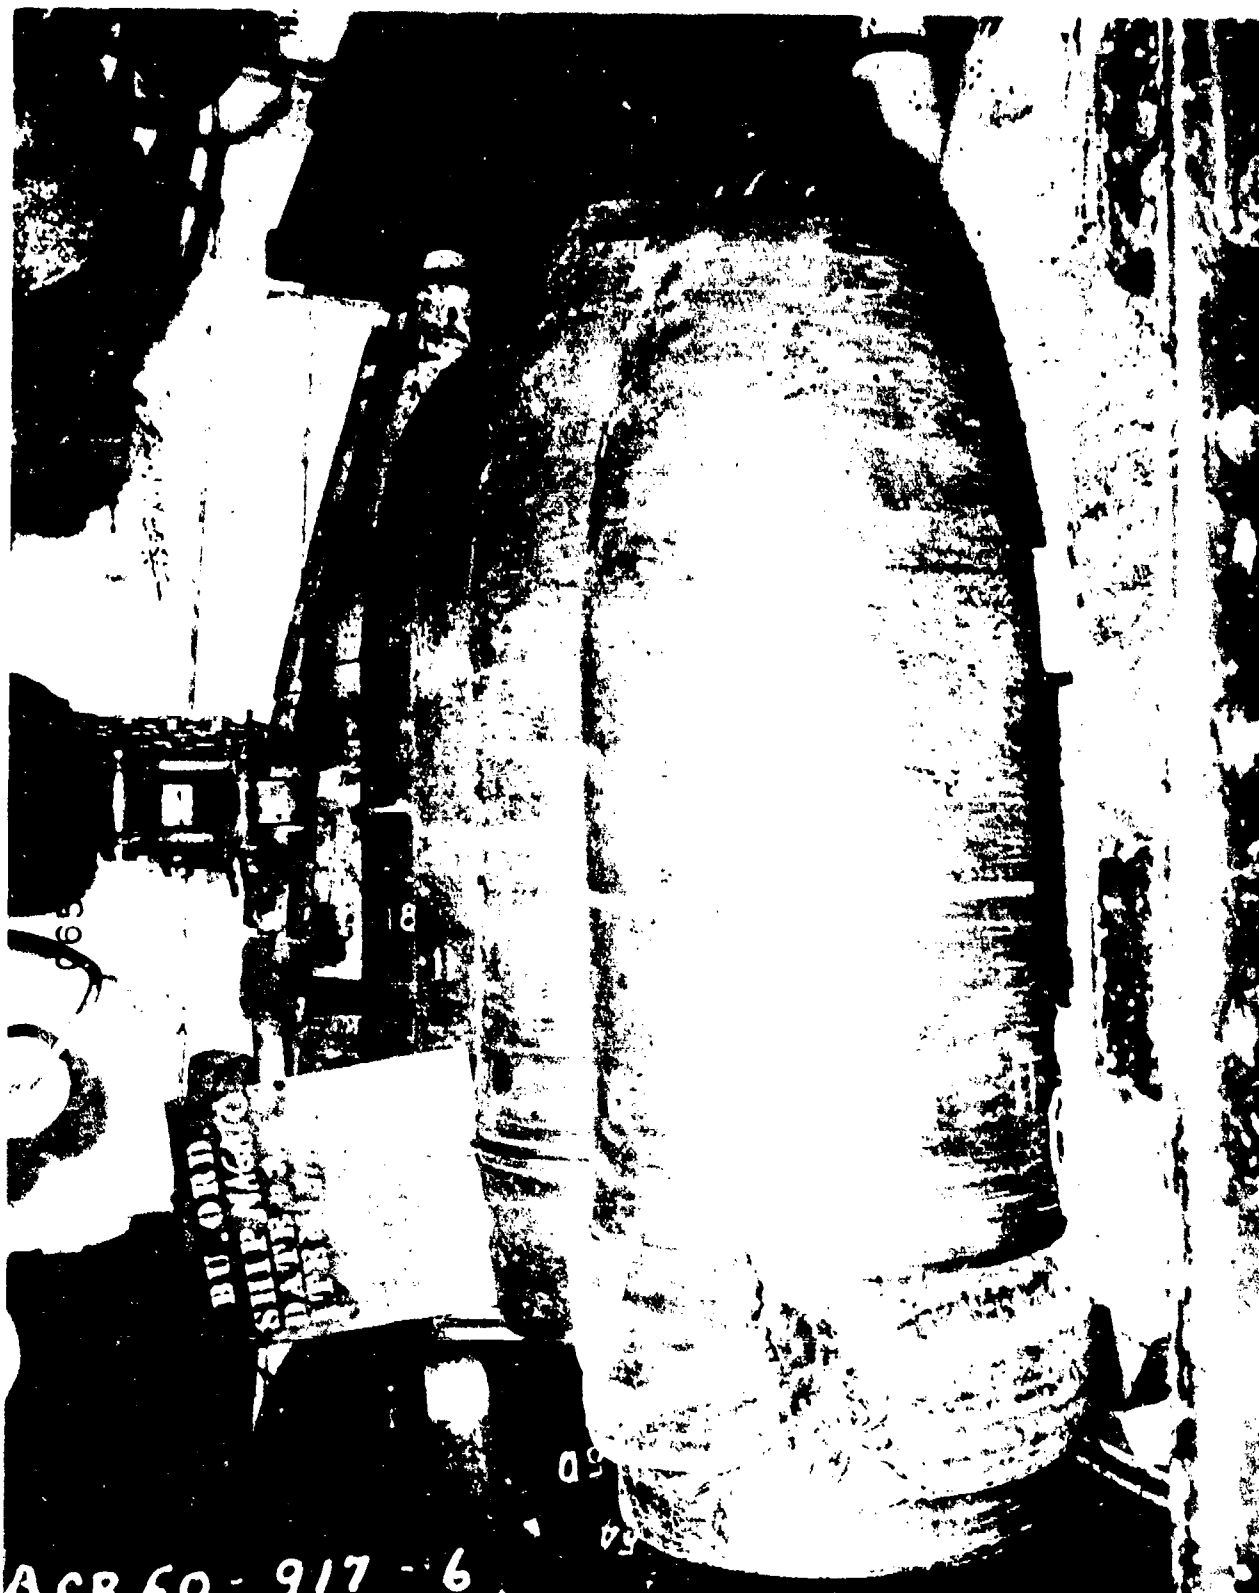
U.S.S. NAGATO (Ex-Jap BB) - Before Able  
Shows the 40 CM, Common, projectile stowage on the  
Shell Deck of No. 1 Turret.  
Photo. No. BA-CR-60-917-6.

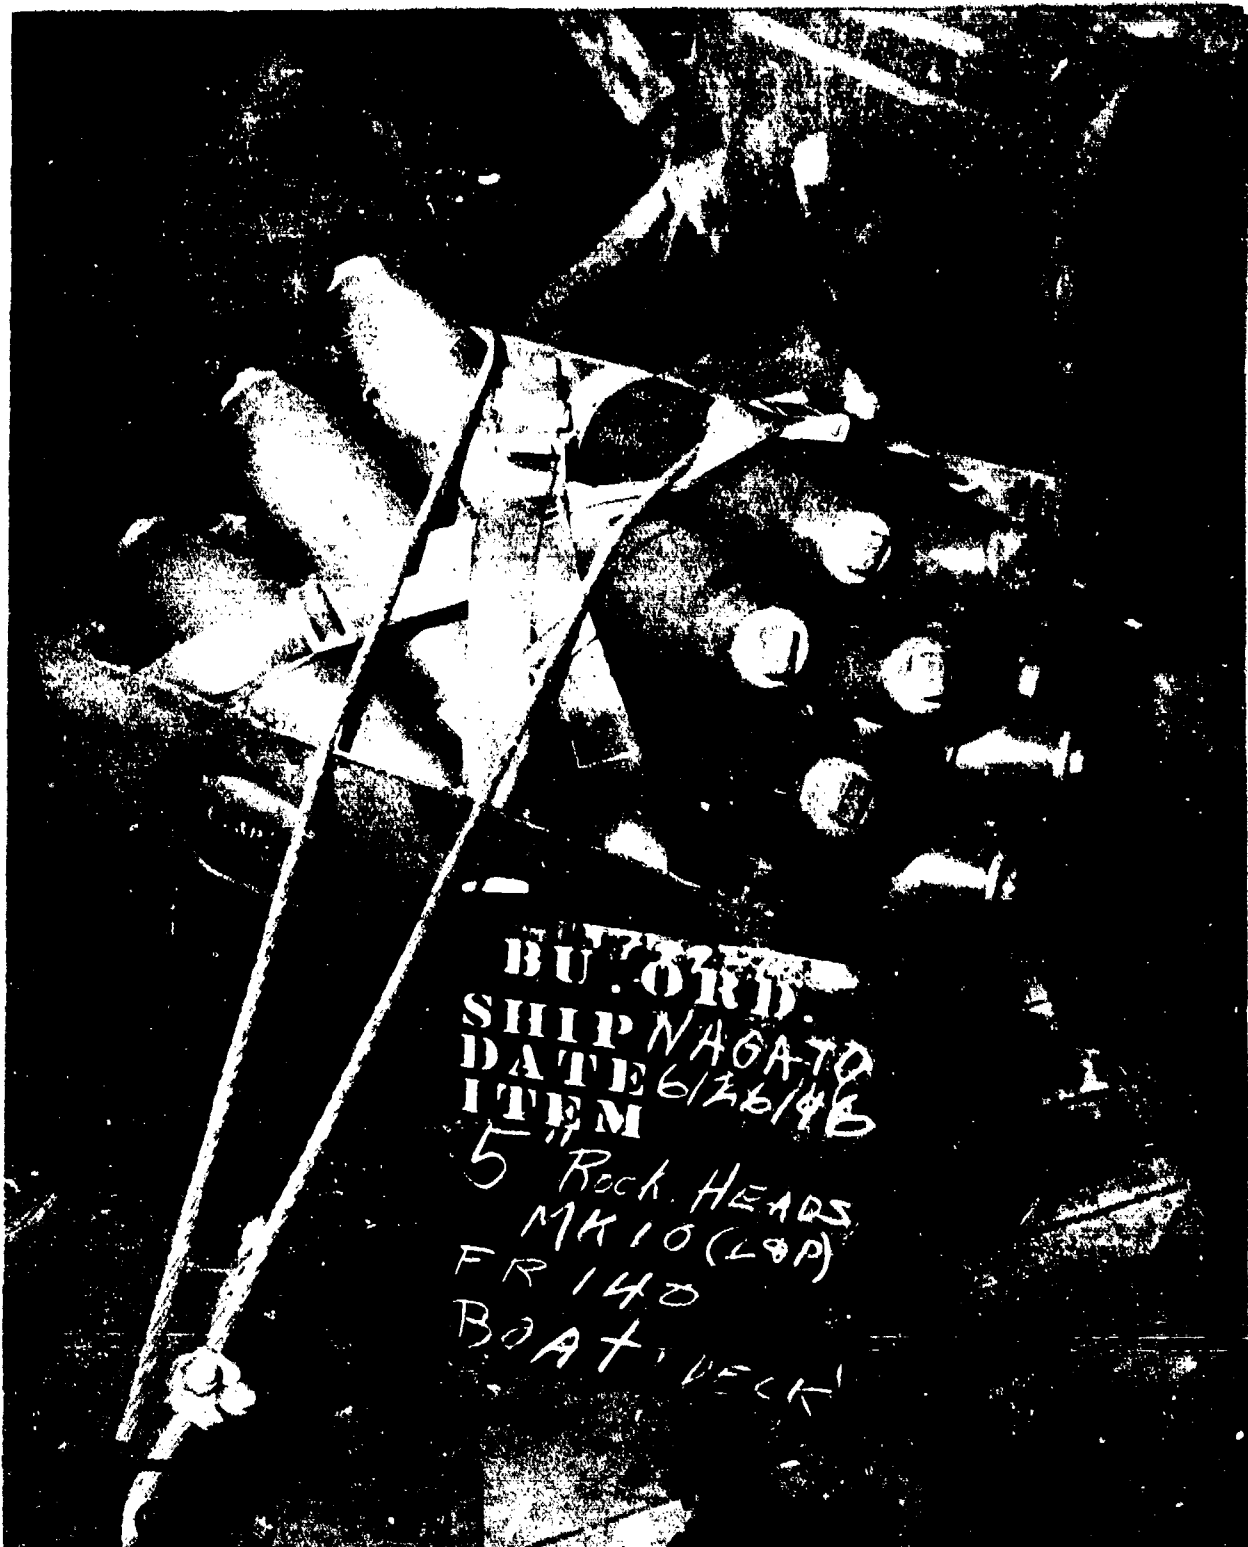
U.S.S. NAGATO (Ex-Jap MB) - Before Able  
Shows the method of securing and the 5" aircraft rocket  
heads, Mk. 10, Mod. 0, TNT loaded and plugged in position  
for Test "A". The rocket heads were located on the boat  
deck, frame 140, starboard side.  
Photo. No. BA-Ck-76-1799-1.

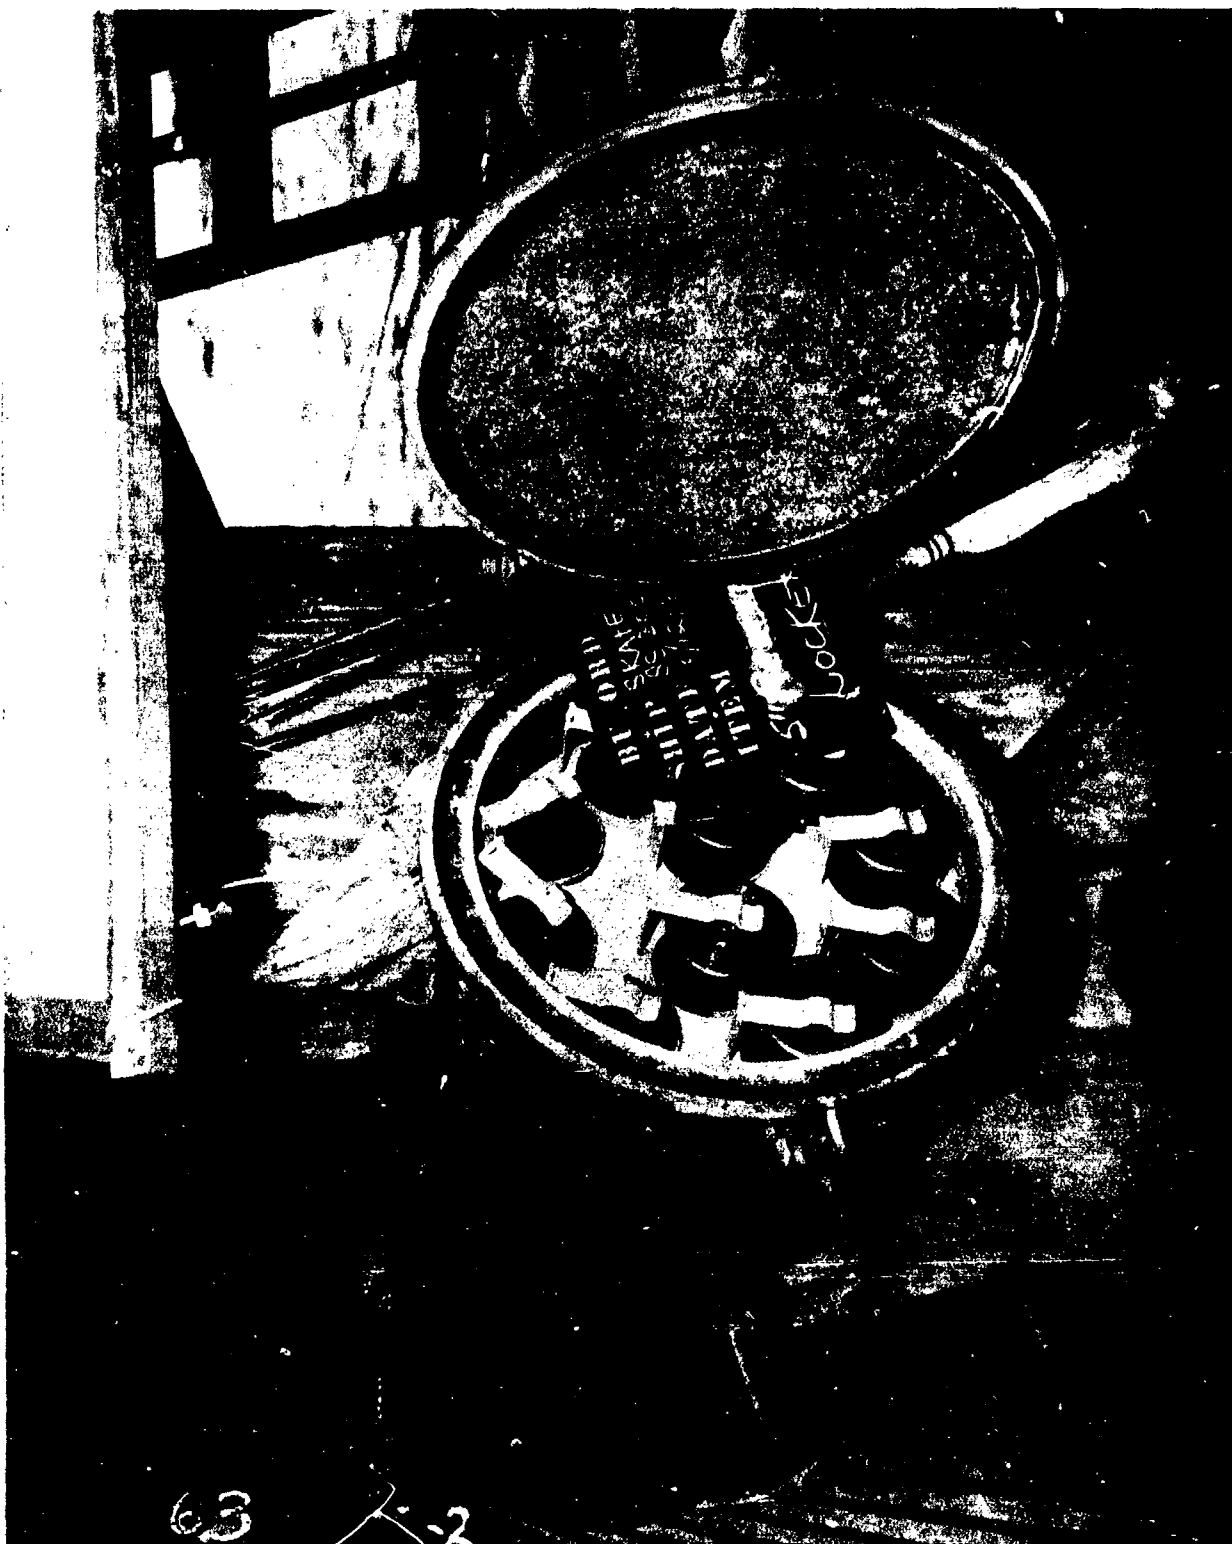
U.S.S. SKATE (SS-305) - Before Able  
Shows the percentage of service allowance  
ammunition placed in the ready service locker  
for Test "A".  
Photo. No. BA-CR-63-946-2.

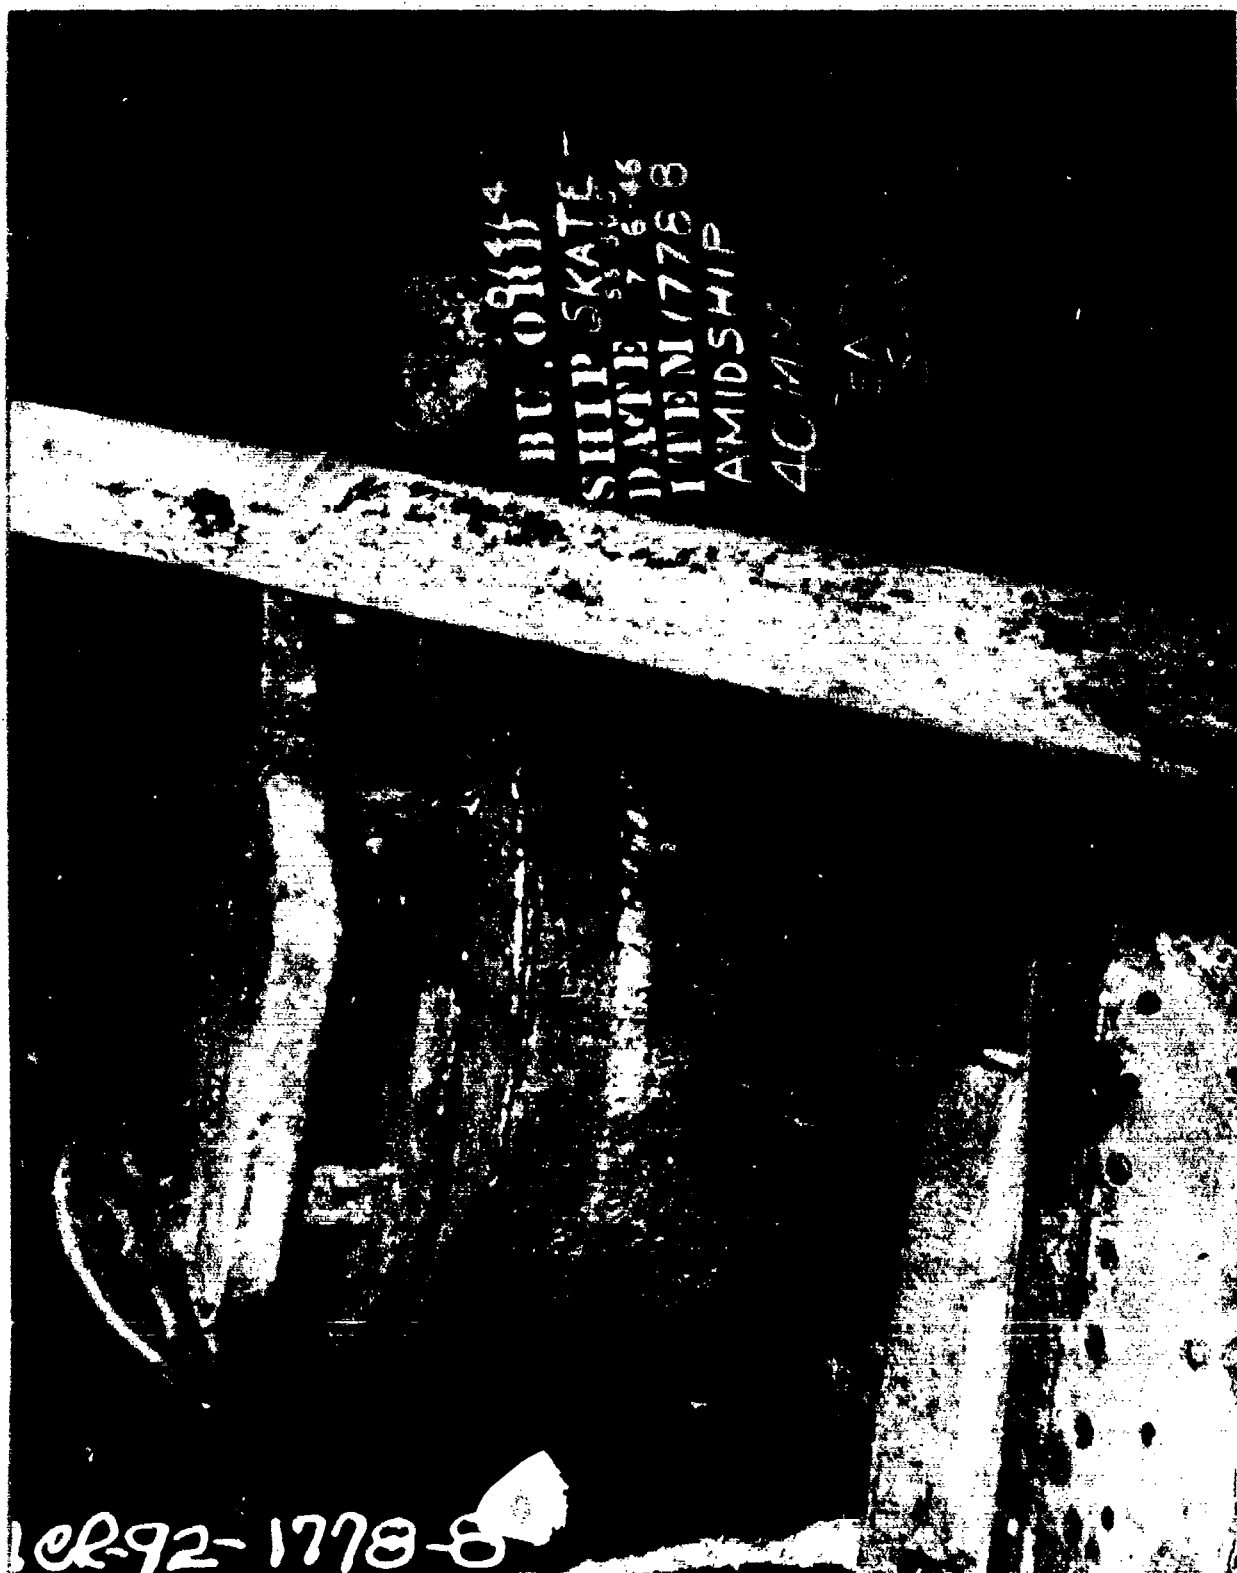
U.S.S. SKATE (SS-305) - After Able  
Shows the condition of the 40 MM Ready  
Service Box after it had been subjected  
to terrific blast. Ammunition within the  
Ready Service Box remained unharmed.  
Photo. No. AA-CR-92-1778-8.

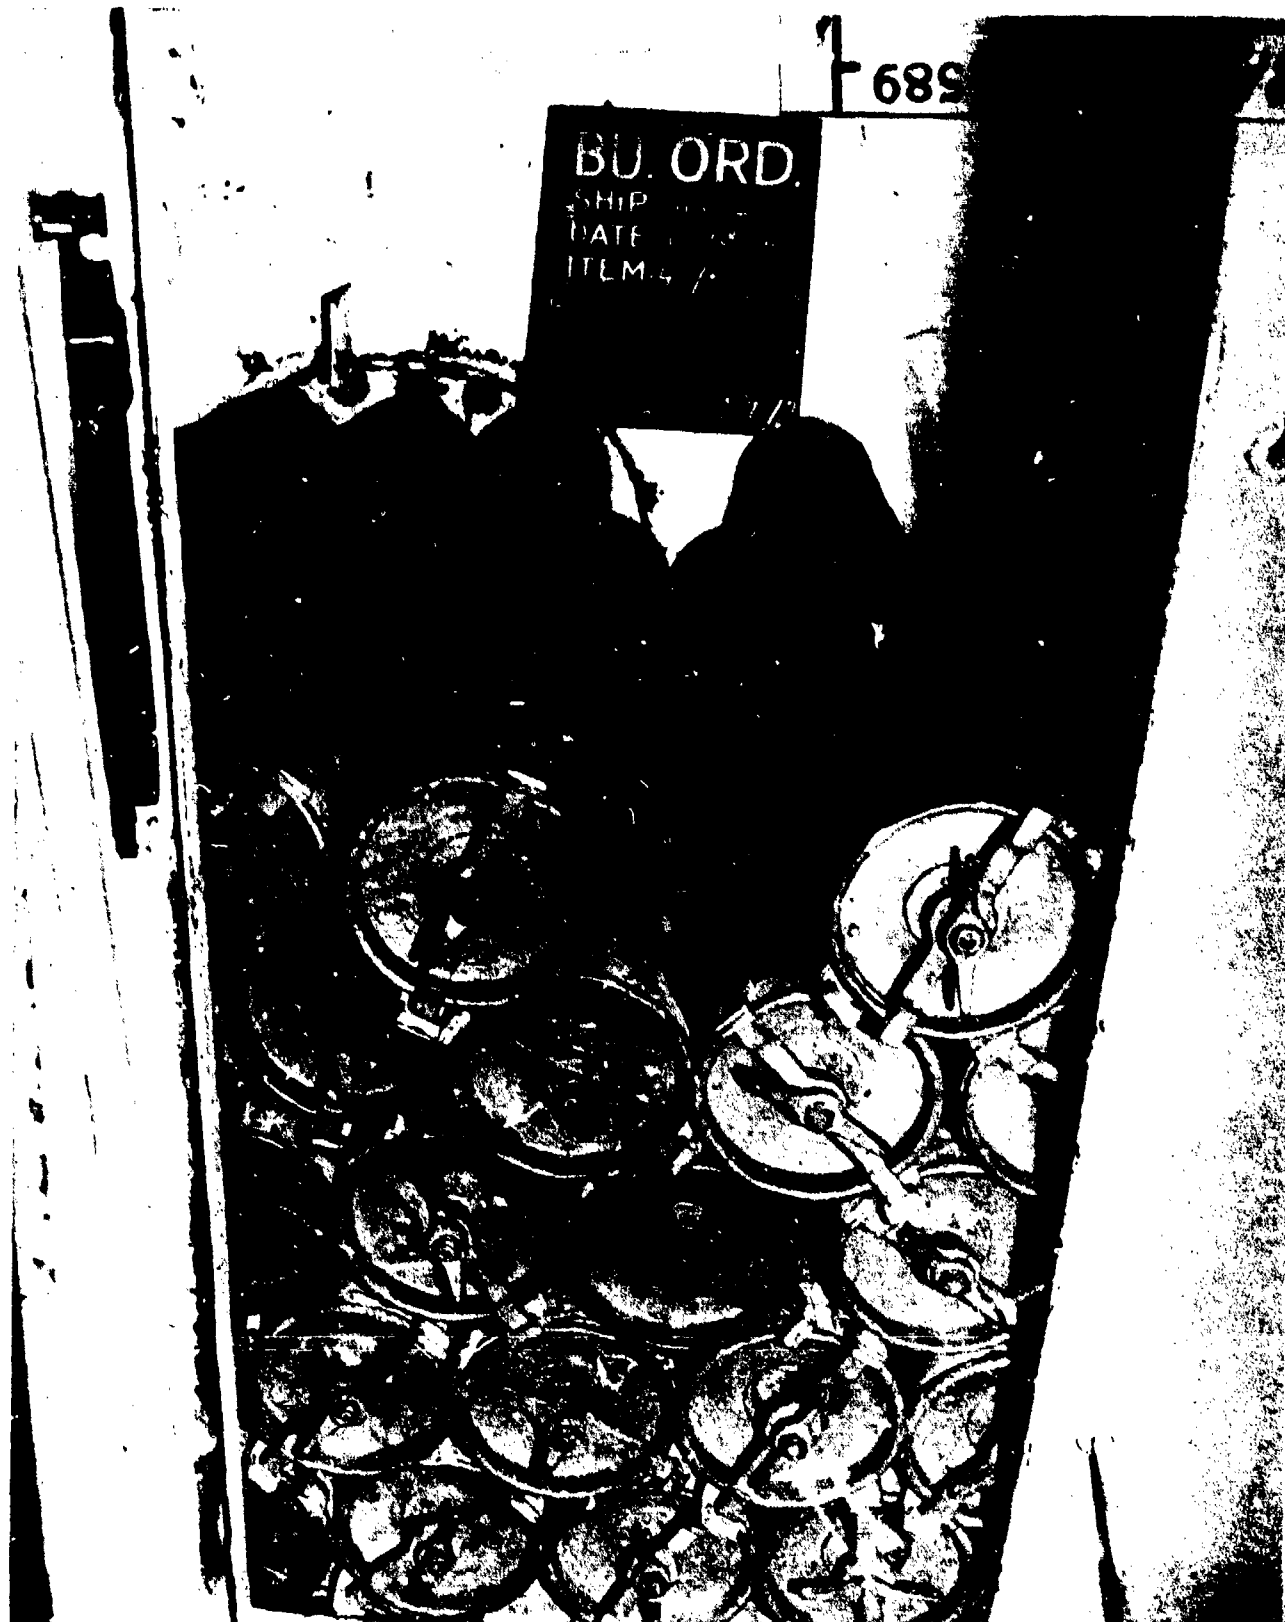
U.S.S. SEARAVEN (SS-196) - Before Able  
Shows the 4"/50 Powder Stowage below the  
Crew's Mess in position.  
Photo. No. BA-CR-97-589-12.
